# HUMBOLDT BAY HARBOR, RECREATION AND CONSERVATION DISTRICT

For Fairhaven Terminal Dock  
Repair and Maintenance

Attachment A  
Application for 5-year Repair and Maintenance Project  
1900 Bendixon St, Samoa, CA 95564 (APN 401-301-008)

**RE:** Coastal Development Permit for a 5-year Repair and Maintenance Plan for Sequoia Investments, LLC - Fairhaven Terminal Dock (APN 401-301-008)

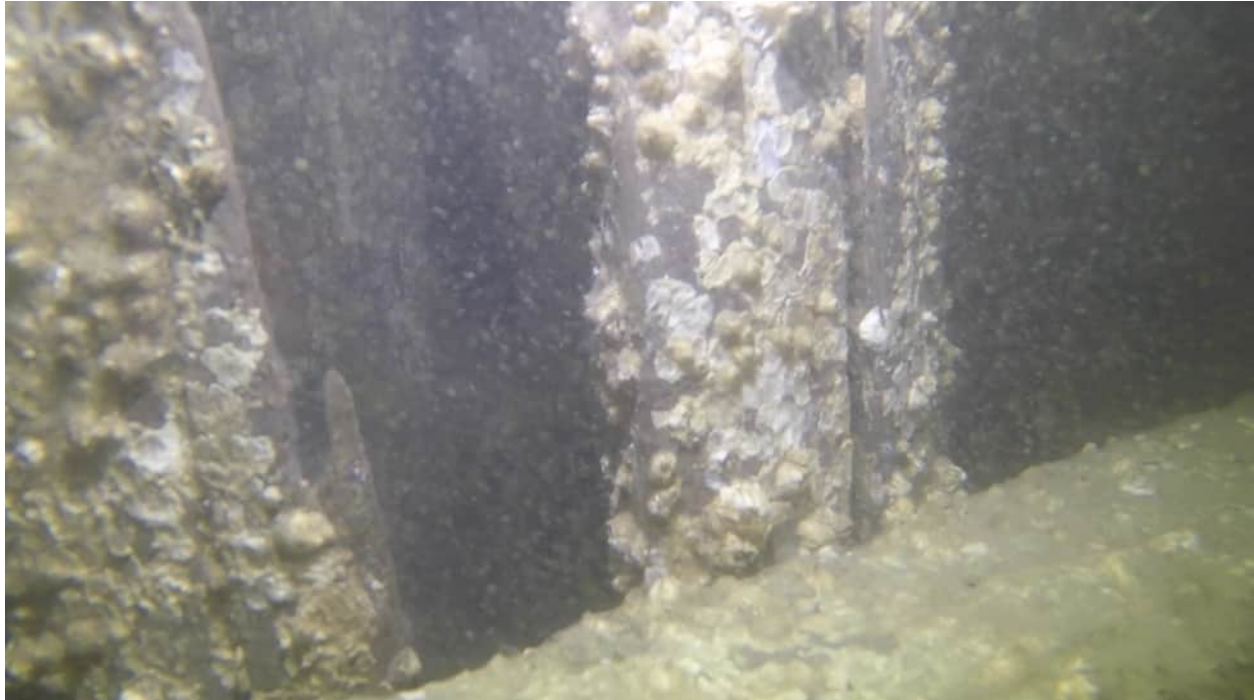
Pile 30E Severe Damage - timber pile hollow from surface down to base

2.1. Project engineers should inspect all piles and connections above MLLW

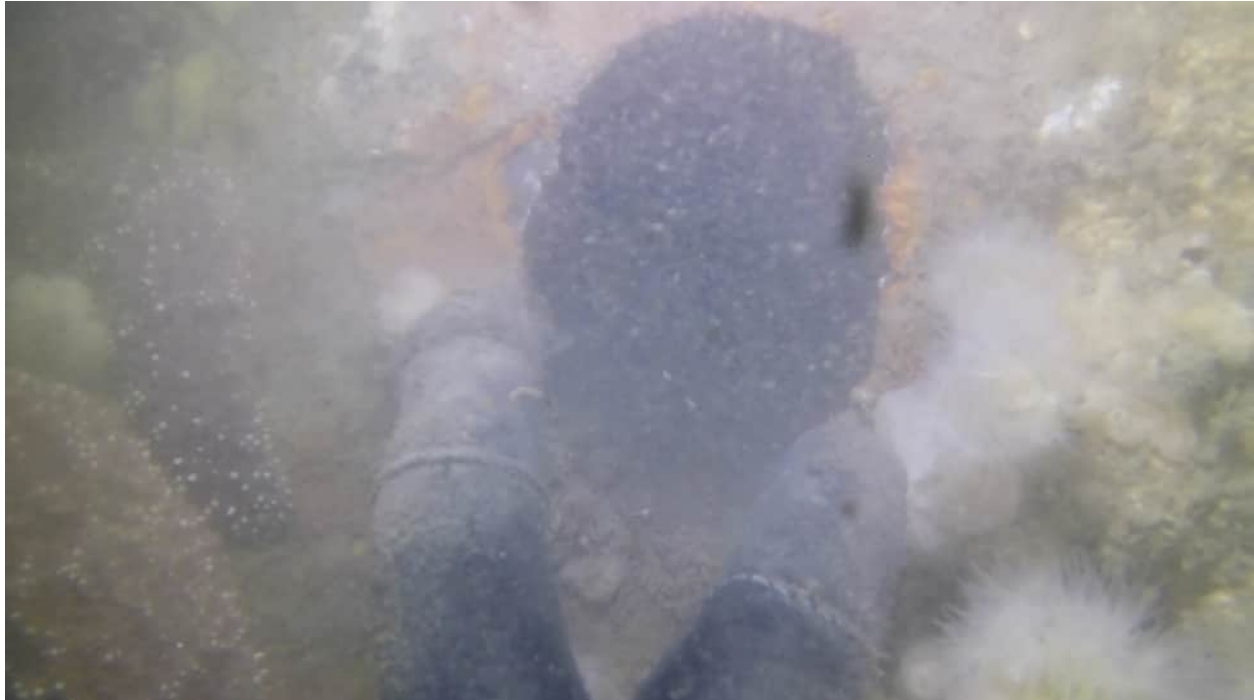
1.4.2.2. Holes found in NC1

Pile #NC1 Moderate Damage - steel pile with hole

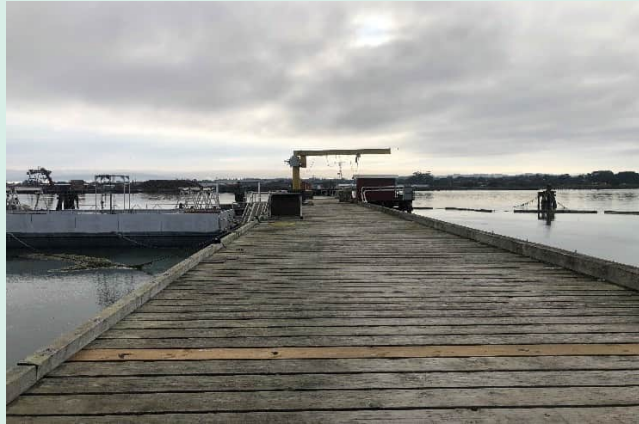
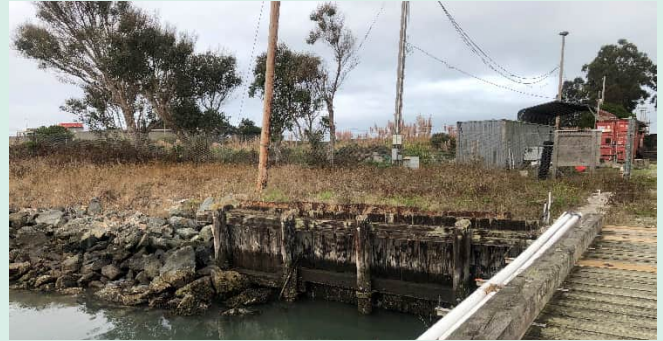
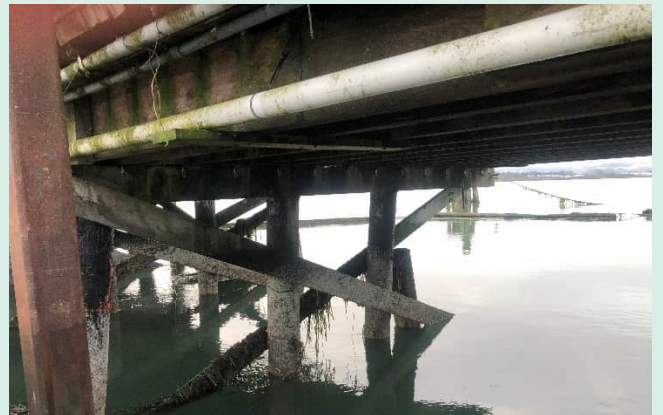
Cover photos taken by Stillwater Sciences (clockwise from top left): View of the Hog Island dock looking east; shoreline bulkhead and riprap at the west end of dock; some of the pilings needing replacement; aerial view of terminal; eelgrass and juvenile Dungeness crab (not at the Hog Island site).

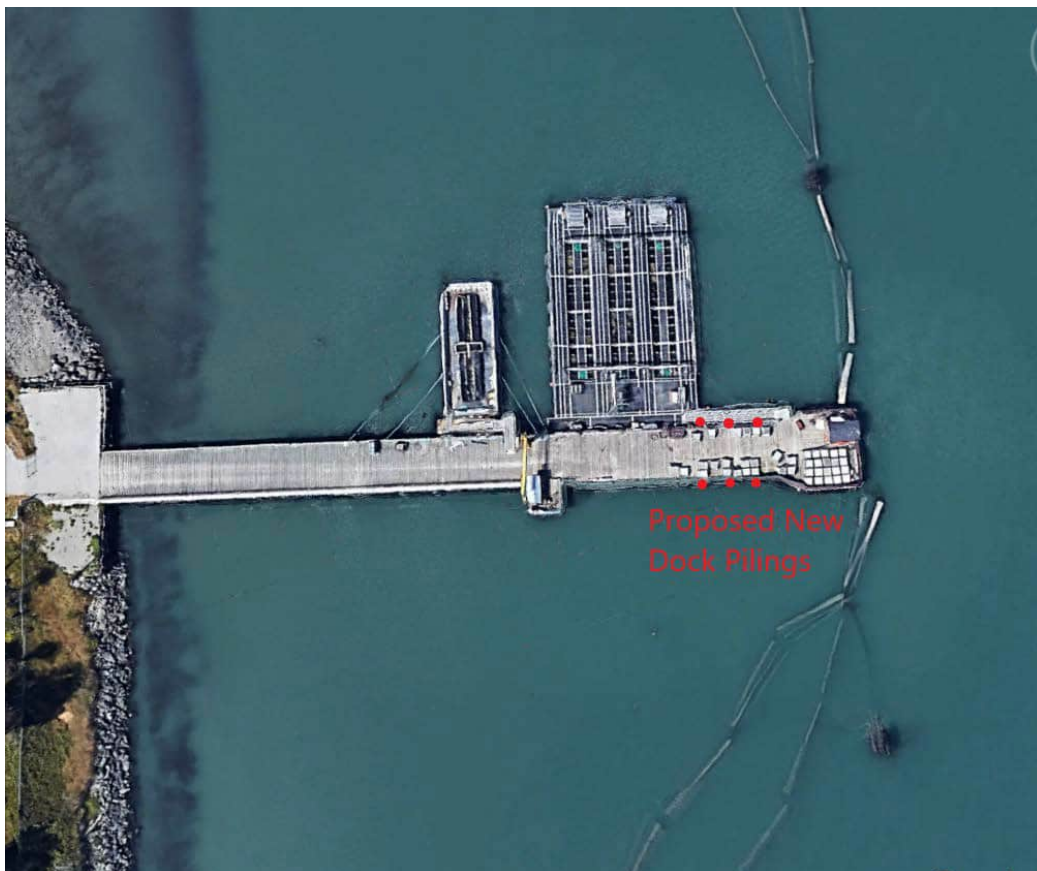
Figure 2. Hog Island dock with work area and eelgrass visible in shallow water along the western shoreline.

The Project will replace 12 existing 12-inch diameter wood pilings (three rows of pilings, four pilings to a row) with six new 12-inch steel pilings (three rows of pilings, two to a row) (Figure 2). The existing wood cross-member beams will be replaced with new steel I-beams (pile caps) that will be welded or bolted to the steel pilings. The repair work will occur within a 625 square ft area. No laydown areas or work are planned along the shoreline or the western expanse of the dock.

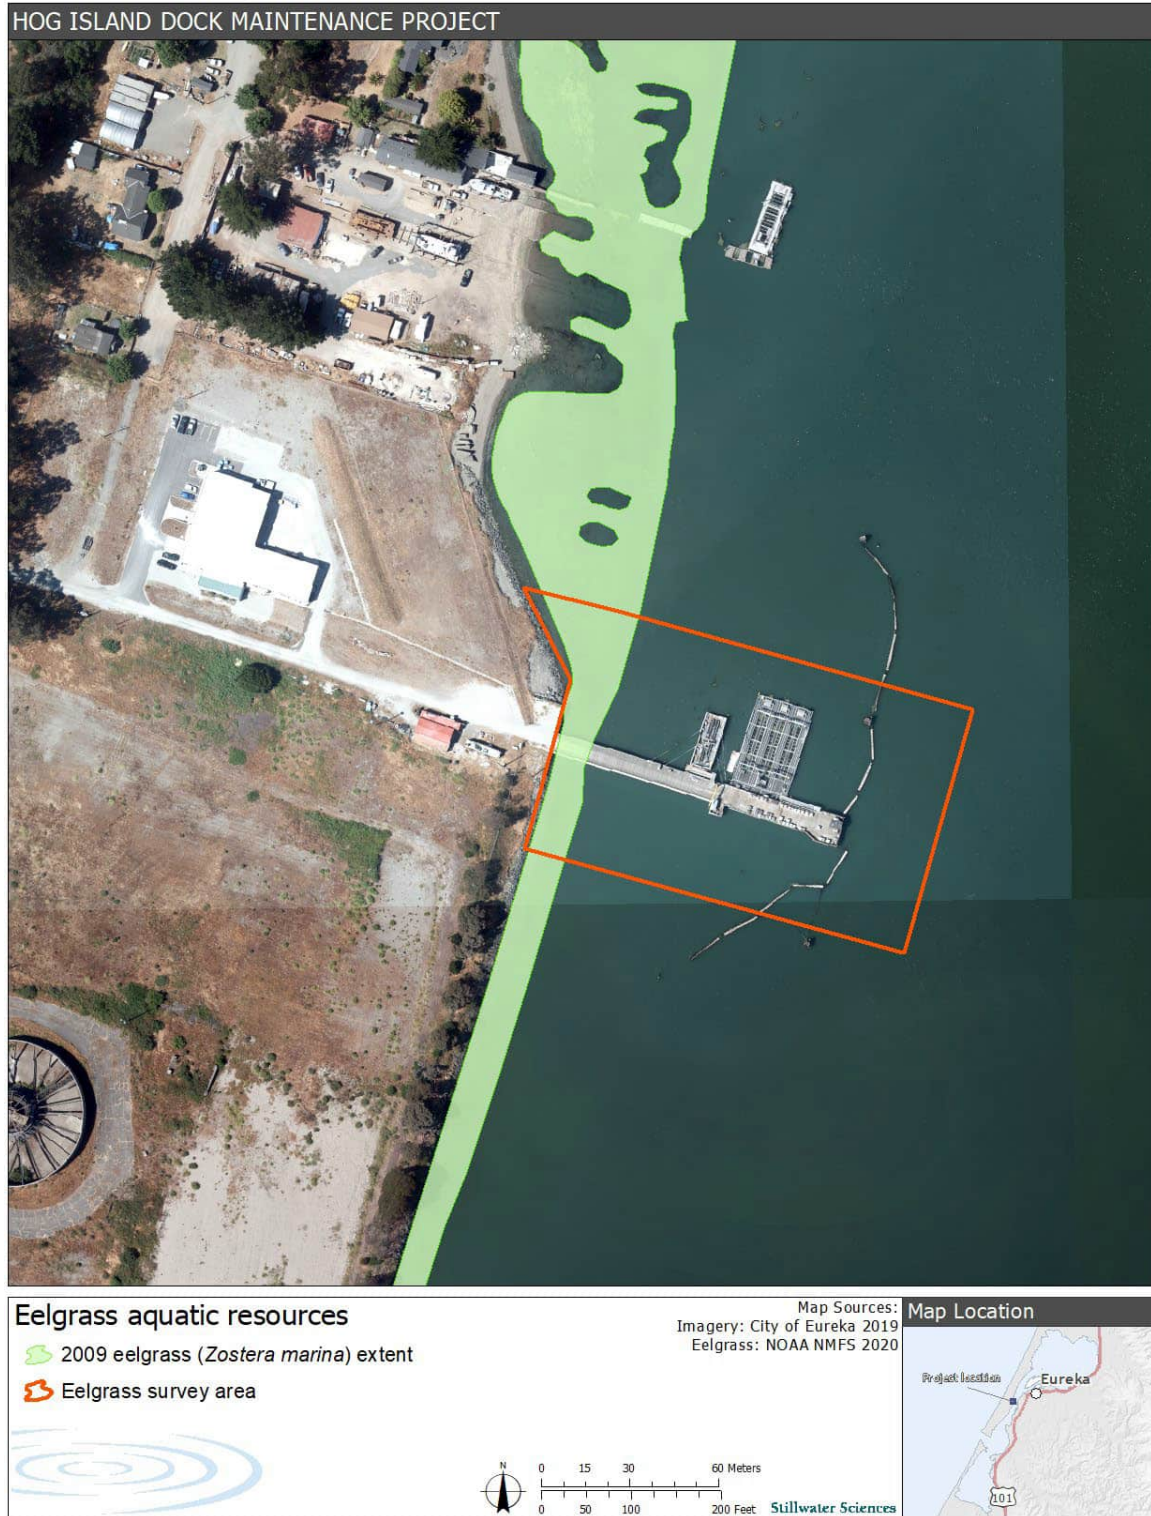
Figure 2. Eelgrass documented in 2009 in the vicinity of the Project area.

A narrow strip of eelgrass is located along the shore in the vicinity of the Project work area (Figure 2). Eelgrass does not have a California Rare Plant Rank from the California Department of Fish and Wildlife (CDFW) and is not federally or state-listed species. However, it is given special protection due to its importance as a nursery area for groundfish species. Eelgrass provides a variety of essential ecosystem functions, including primary production, predation refuge, nursery functions, physical structure, and nutrient cycling. Eelgrass habitat has been identified as a "Habitat Area of Particular Concern" as a subset of Essential Fish Habitat, a category of fish habitat protected under a provision of the Magnuson-Stevens Fishery Conservation and Management Act. Eelgrass has also been identified by the California Coastal Commission (CCC) as essential to the health and productivity of the Humboldt Bay ecosystem. Special Condition 3 of the Project CDP (1-22-0064) requires pre- and post-construction surveys to ensure that no net loss of eelgrass occurs as a result of Project activities.

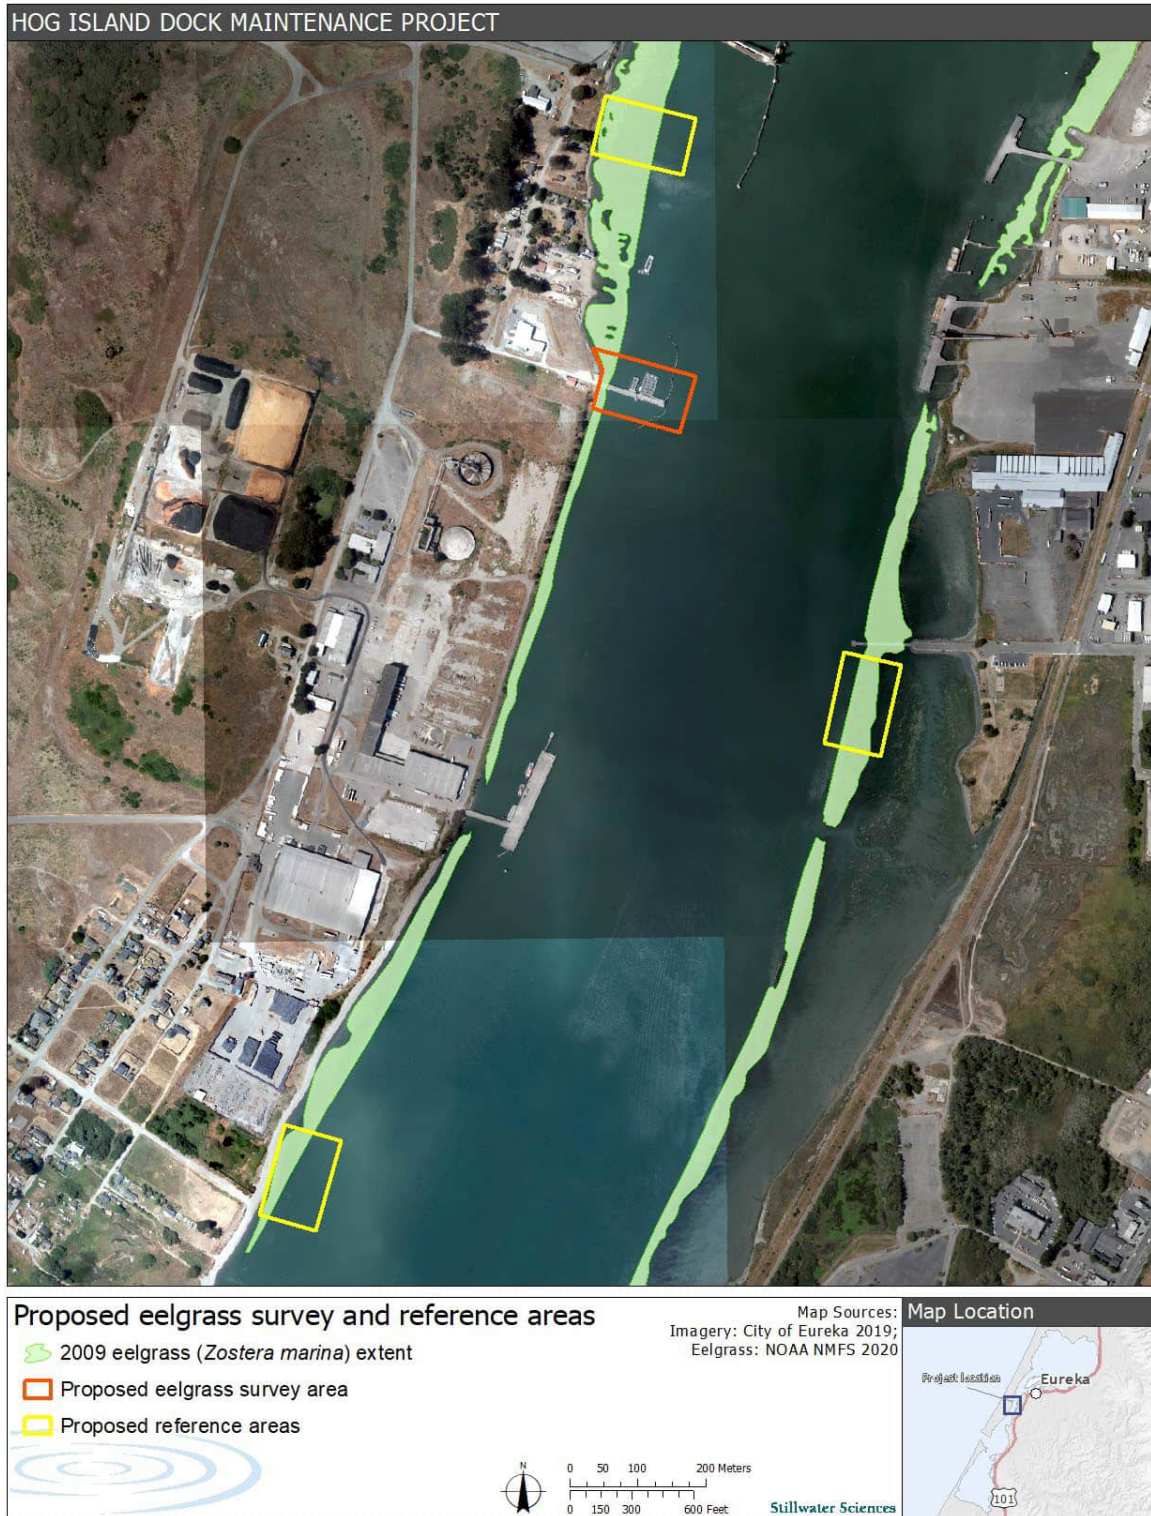
Figure 3. Proposed eelgrass survey area and reference areas in the vicinity of the Project area.

A comparable reference site will also be monitored to isolate the effects of Project activities from the natural variability of eelgrass beds. Figure 3 shows three potential reference sites that will be surveyed at the same time as the survey area. One site will be selected at the time of the survey based on site conditions, access, and how well it compares with the Project survey area. The selected reference area will then be used for the rest of the five-year monitoring period. The reference area will be of equal or greater area to the eelgrass survey area and will be located far enough from the Project area to avoid any potential indirect impacts of construction activities (Figure 3).
